Monitoring Data Record

Project Title: B-3126 (Br. #90 over Gunpowder Creek on SR 1718
 COE Action ID: 2007-1591-214 DWQ Number: 070583
 Stream Name: Tributary to Gunpowder Creek
 City, County and other Location Information: Caldwell County, Bridge #90 over
Gunpowder Creek on SR 1718 (Deal Mill Road) near Granite Falls.
 Date Construction Completed: 3/11/09 Monitoring Year: (5) of 5
 Ecoregion: _____ 8 digit HUC unit 03050101
 USGS Quad Name and Coordinates: Granite Falls N 35.84415, W 81.43603

Year 5 Winter – January 2013

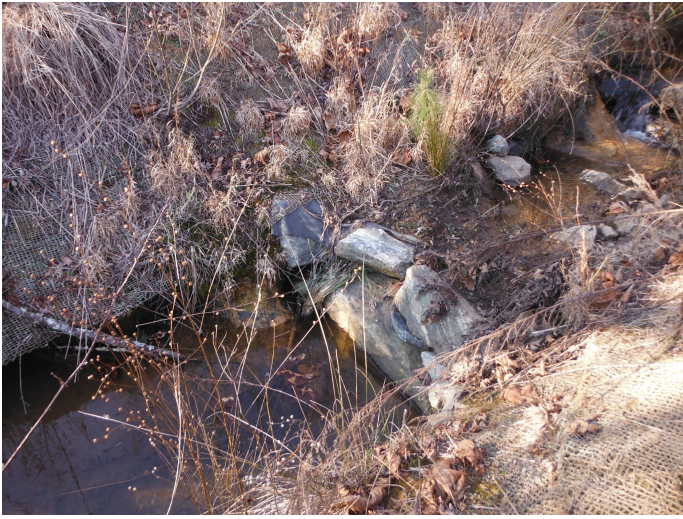
This is the Year 5 Winter evaluation for the Tributary to Gunpowder Creek. Water continues to pipe under the crossvanes at Sta. 2+50 -NSD- and 3+10 -NSD- but is not causing any instability issues at this time. On two separate occasions in December 2011 and in January 2012, NCDOT attempted to repair the crossvanes. NCDOT will continue to monitor the channel stability at this stream relocation. A site visit was conducted on June 16, 2011 with the regulatory agencies and NCDOT personnel present.

Water piping under crossvane @ Sta. 2+50-NSD-

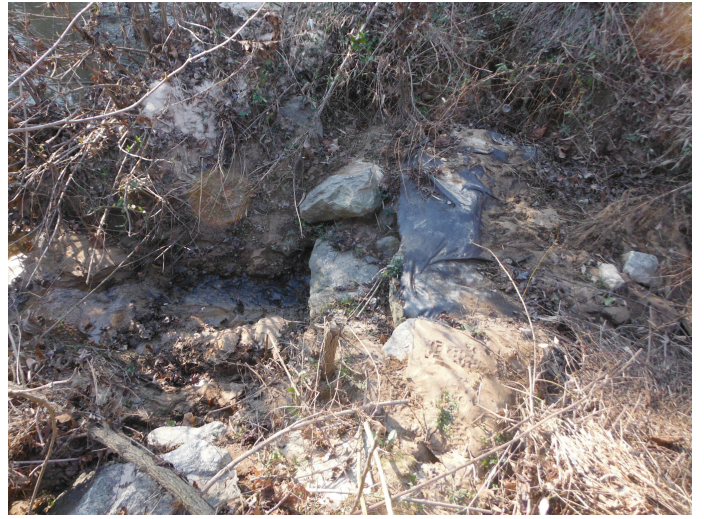
Water piping under crossvane @ Sta. 3+10-NSD-
